FINAL TECHNICAL REPORT

A CRITICAL STUDY OF THE ROLE OF THE SURFACE OXIDE LAYER IN TITANIUM BONDING

National Aeronautics and Space Administration

Grant NAG 1-252

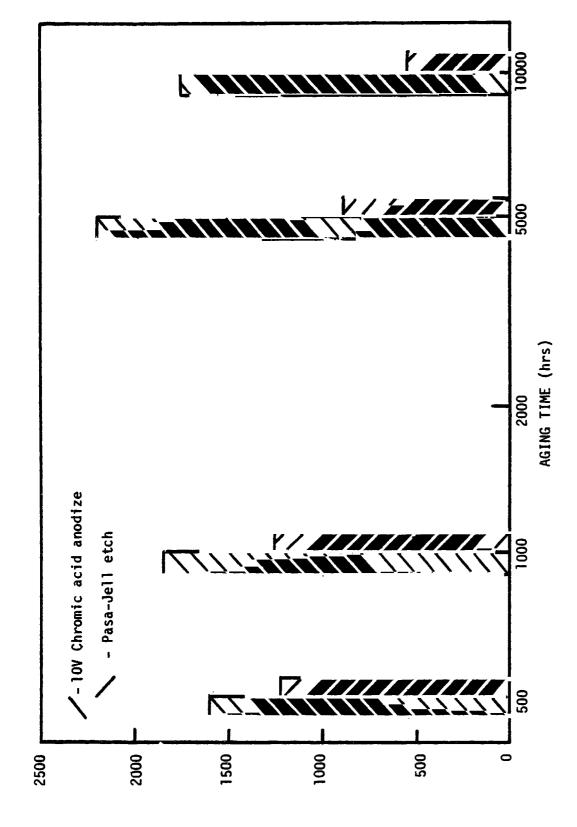
The lap shear strengths of Ti 6-4 adherends pretreated by the Pasa Jell process and by 10V chromic acid anodize, bonded with NR 056X and then aged at 450°F from 500 to 10,000 hrs are shown comparatively in Figure 1. The consistently lower lap shear strengths for the Pasa-Jell pretreated Ti 6-4 adherends may be due to the diminished mechanical interlock in a thinner oxide layer as reported (11) for this particular pretreatment. Indeed, after 10,000 hrs at 450°F, the 10V chromic acid anodized sample No. 056-10-65 still failed cohesively whereas the Pasa-Jell sample No. 056-P-37 failed interfacially.

Lap shear strengths for 056X bonded Ti 6-4 adherends pretreated by 10V chromic acid anodize and by Pasa-Jell etch as a function of aging time at 450° F. Figure 1.

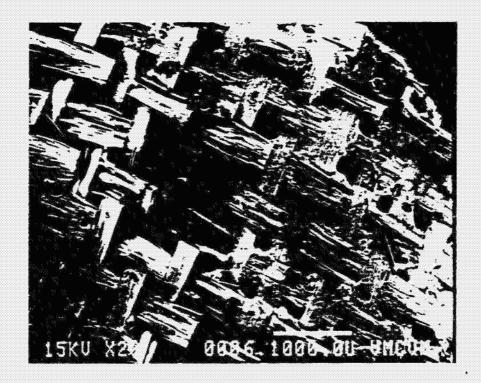
contrast a SEM photomicrograph of the fracture surface of a representative cohesively failed sample (No. 056-10-60) is shown in Figure 3. It is obvious that fracture occurred within the adhesive exposing scrim cloth, some areas of which appeared not to have been wetted by the adhesive.

Figure 3. SEM photomicrograph of adhesive failure surface for Sample No. 056-10-60.

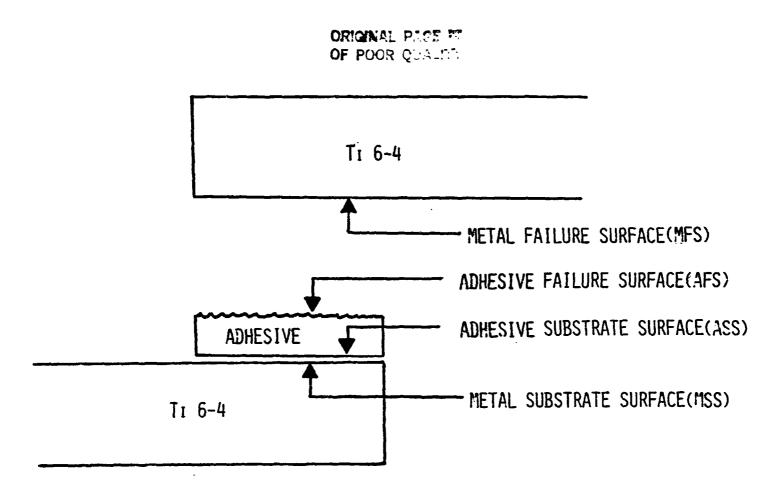
Figure 1. Schematic of fractured lap shear specimen.

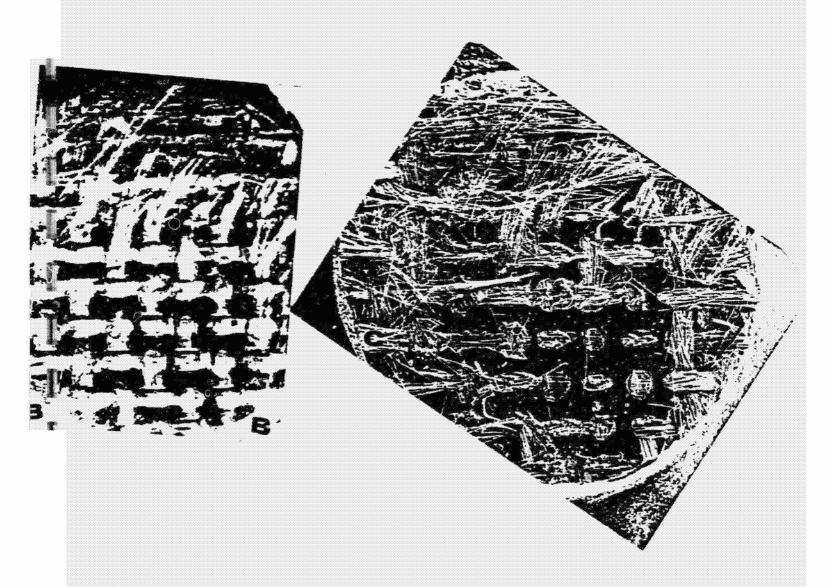
Extensive microscopy work was done on the samples listed in Table I. However, microscopy is reported for only two samples representative of cohesive and interfacial failure. A photograph of the fractured lap shear Sample No. PPQ-10-46 which failed cohesively is shown in Figure 2A. An OM photomicrograph of a sample punched from the indicated region of Side I is shown in Figure 2B. An SEM photomicrograph of the same sample is shown in Figure 2C. The cohesive failure of this sample involved extensive disruption of the glass scrim cloth. No features characteristic of the Ti 6-4 adherend are seen in the SEM photomicrograph. EDX analysis of this sample showed only Ca and Si signals characteristic of glass.

Figure 2. (A) Photograph of fractured lap shear sample (B) Optical photomicrograph of punched sample (C) SEM photomicrograph of punched sample.

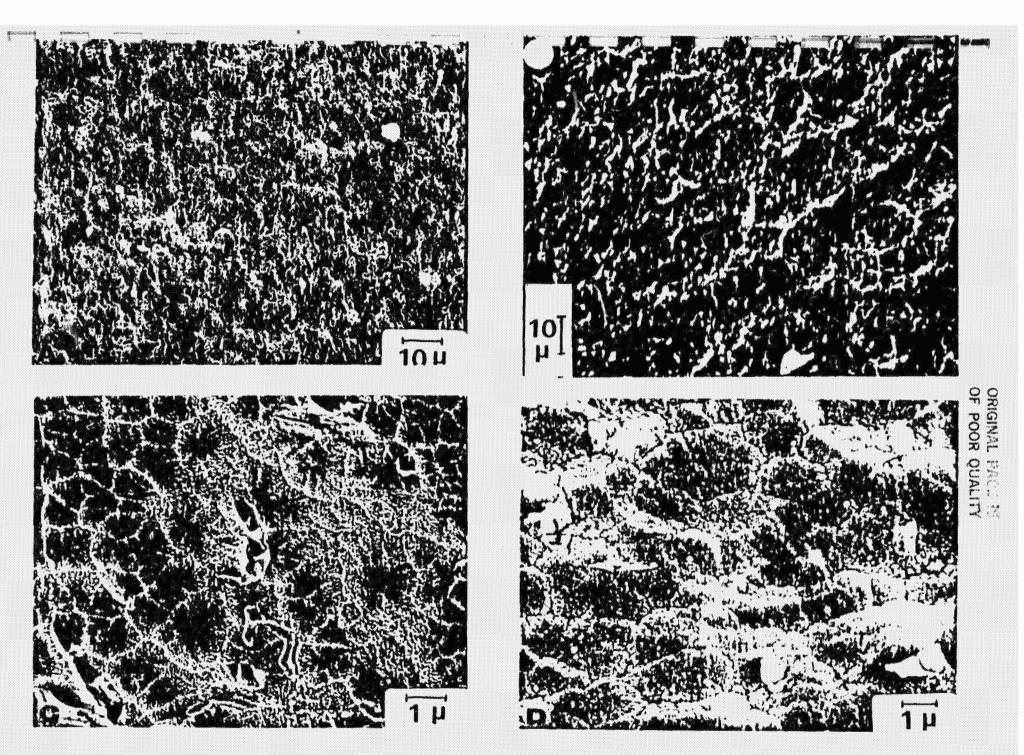
In contrast, SEM photomicrographs for Sample No. PPQ-D-5 which failed interfacially are shown in Figure 3. The adhesive failure surface (AFS) and the metal failure surface (MFS) are shown in Figures 3A and 3B, resp. Features characteristic of the acid etched phosphate-fluoride pretreated Ti 6-4 surface (9) are seen in Figure 3B. Imprints of the β -phase of the alloy are clearly seen in the adhesive of the adhesive failure surface (AFS) in Figure 3A. The metal substrate surface (MSS) is shown at higher magnification in Figure 3D. Again the imprint of this surface is seen in the adhesive on the adhesive substrate surface (ASS) in Figure 3C, as evidenced by the voids left by pull-out of the β -phase.

Figure 3. SEM photomicrograph of Dample No. PPQ-D-5. (A) AFS (B) MFS (C) ASS (D) MSS.

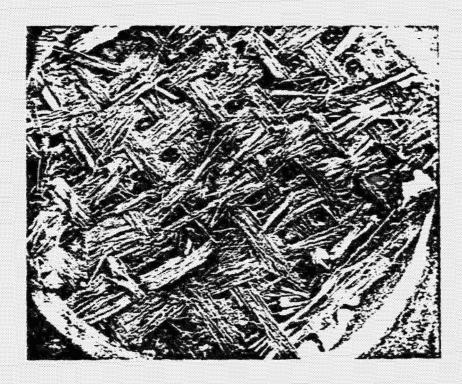
Extensive microscopy work was done on the samples listed in Table 1. However, microscopy is reported for only two samples, representative of cohesive and interfacial failure. A photomicrograph of the fractured lap shear Sample No. L13-10-53 which failed cohesively is shown in Figure 1. The cohesive failure of this sample involved excensive disruption of the glass scrim cloth. No features characteristic of the Ti 6-4 adherend are seen in the SEM photomicrograph. EDX analysis of this sample showed only Ca and Si signals characteristic of the glass.

Figure 1. SEM photomicrograph of Sample No. L13-10-53.

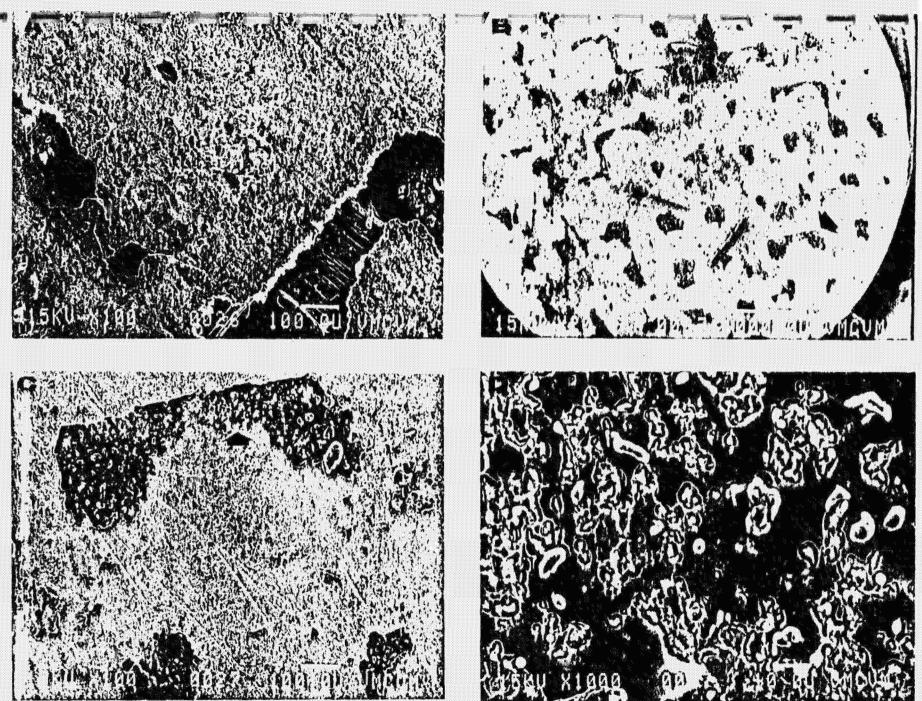
coated scrim cloth is visible in the large void. A number of alumina particles contained in the L13 adhesive are seen in the center of the photomicrograph. The same metal failure (MFS) at increasing magnification is shown in Figs. 2B-2D. Arrows indicate areas which appear at higher magnification. Patches of adhesive are seen on the Ti 6-4 adherend of the MFS (Fig. 2B). The alumina particles in an L13 adhesive patch are seen in Fig. 2C. Features of the Ti 6-4 adherend surface are seen in Fig. 2D. In addition, there is a smooth adhesive layer covering a large area and the larger alumina particles stand in contrast to the smaller β -phase of the alloy produced by the Pasa-Jell process.

Figure 2. SEM photomicrographs of Sample No. L13-P-36. (A) AFS (B) - (D) MFS.
